Propeller Component Project Update

Materials Engineer-Inorganic Coatings

Naval Air Depot Cherry Point, NC

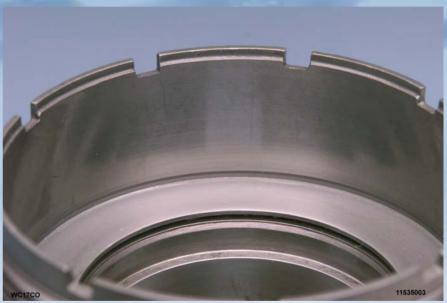
P-3/C-130 Lever Support Sleeve

WC-Co Coated LPSLS

- Cylinder Appearance
 - Chrome Plate Appearance of wear on chrome plate but no significant adhesive wear or scoring
 - WC-17Co Appears untouched
- Piston Ring Appearance
 - Chrome plate Signs of use but no substantial wear
 - WC-17Co Signs of use but no substantial wear

- Quantitative Results
 - Cr-Plate Surface Finish 2.7 Ra at start,
 1.4 Ra at completion
 - WC-Co Surface Finish 7.2 Ra at start,
 7.2 Ra at completion
 - Ring weight loss 3 times higher with Cr plated bore
